Nebagamon Creek Abandoned Railroad Grade Removal Project
Douglas County, WI

Post-Construction Monitoring Summary
October 31, 2024

Wisconsin Department of Natural Resources - Fisheries Management Bureau
Lake Superior Fisheries Team – Superior Office

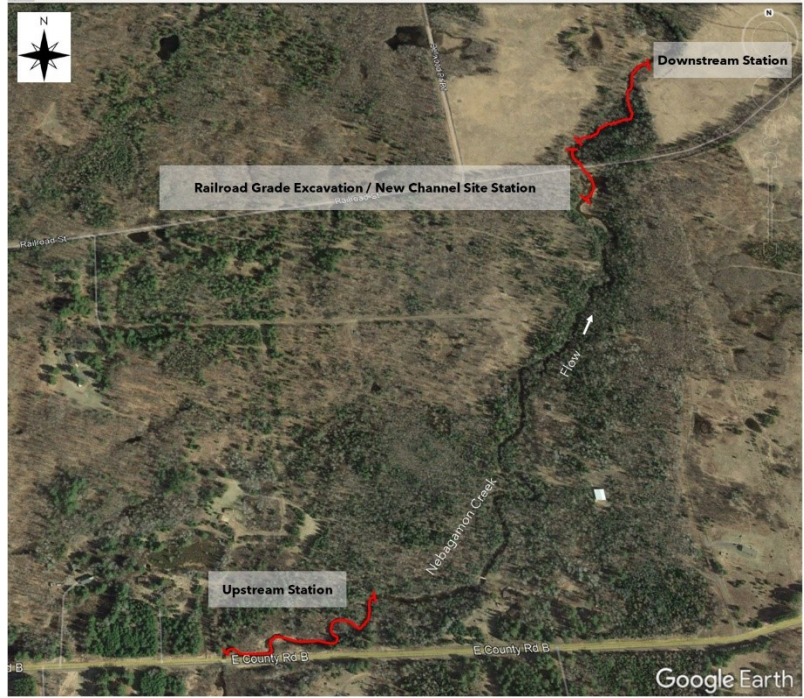
Figure 1. Nebagamon Creek fish survey location map.

Wisconsin DNR conducted three individual post-construction electrofishing surveys in fall 2024: one upstream, one downstream, and one within the new stream channel at the railroad grade excavation site (Figure 1). The surveys were conducted with backpack electrofishing units or a barge electrofishing unit (Figure 2). The upstream and downstream stations are DNR's rotational stations that were established by DNR's Lake Superior Fisheries Team prior to the Project's planning and completion. The station within the new stream channel was established after the Project was completed.

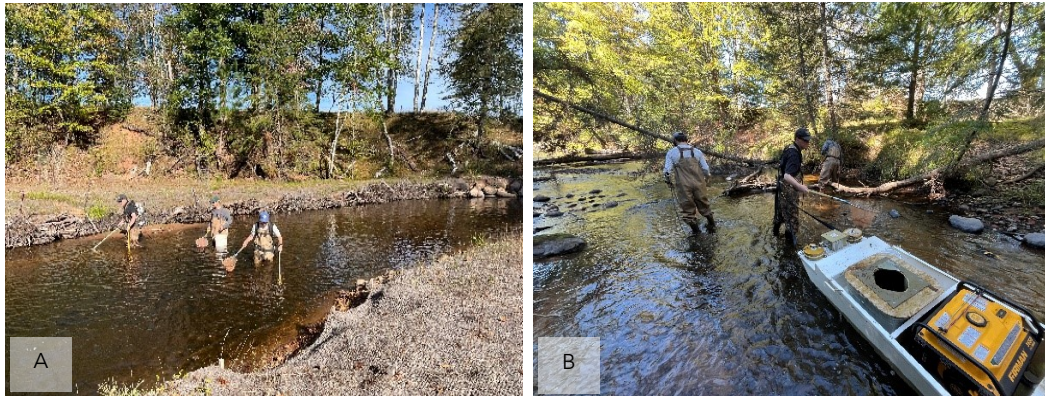
Figure 2. Wisconsin DNR Fisheries crew conducting fish surveys in Nebagamon Creek in September 2024. A: new stream channel, B: existing stream channel downstream from new channel (Photo credits: Wisconsin DNR)

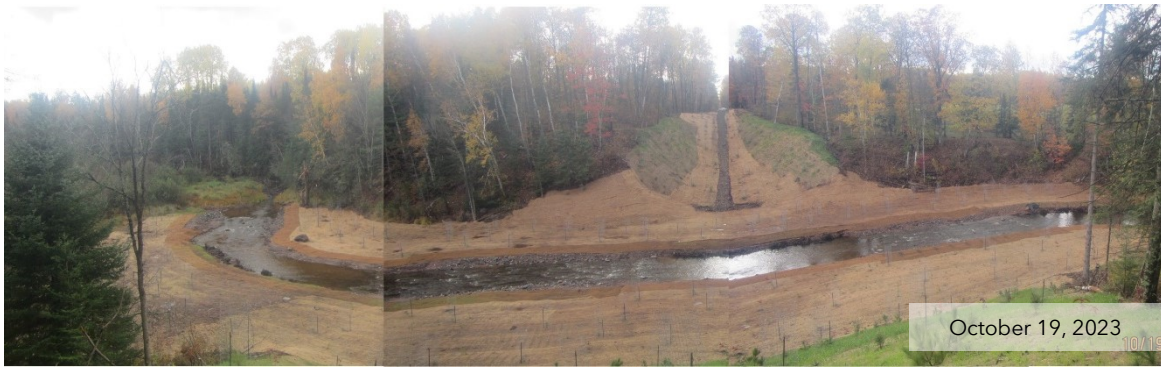
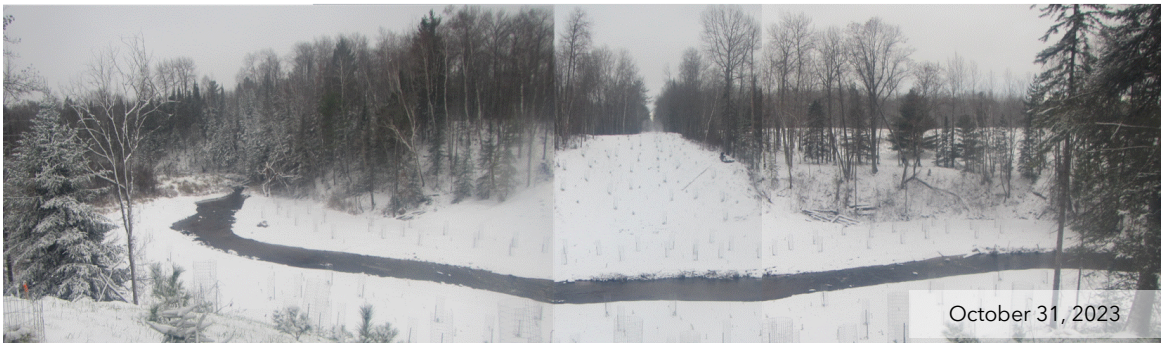
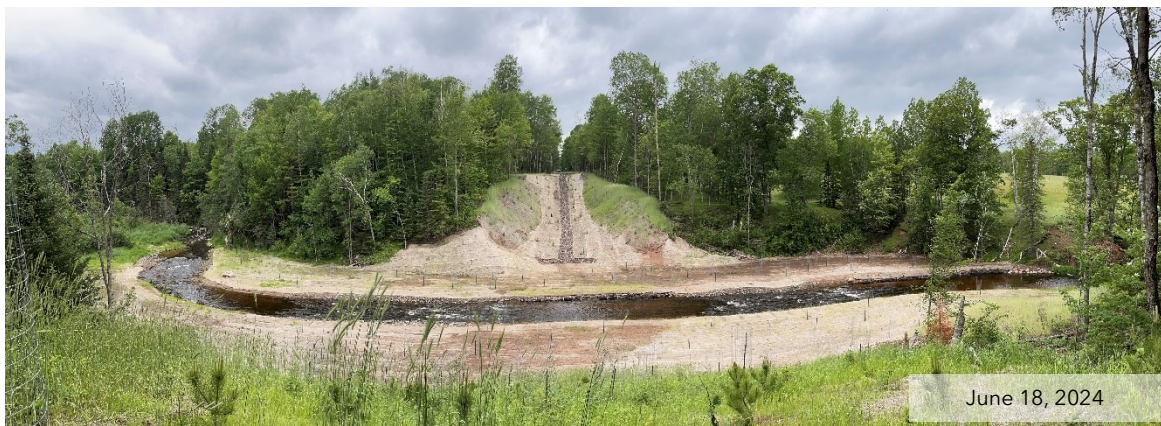
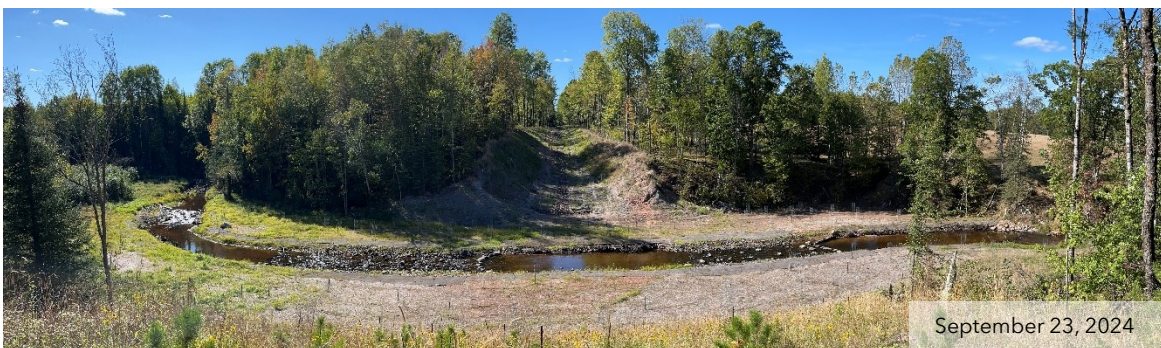
Figure 4. Nebagamon Creek abandoned railroad grade excavation site facing west. (Photo credits: Wisconsin DNR)

Photographic monitoring was conducted at discrete and non-discrete intervals since the Project was completed. DNR maintained its two trail cameras at the excavation/new channel site, one facing upstream and one facing downstream (Figure 3), which recorded photographs at 15-minute intervals. All photographs were submitted to the Great Lakes Fishery Commission, who developed a time-lapse video and published it on its Project web page in July 2024 (<https://www.glfc.org/rhp-nebagamon-creek.php>). Among DNR’s several photograph stations, the top of the eastern embankment was frequently used (Figure 4).
